**DEPARTMENT OF TRANSPORTATION****DIVISION OF ENGINEERING SERVICES**

Contract #: 04-0120F4Cty: SF/ALA Rte: 80 PM: 13.2/13.9File #: 69.28**WELDING INSPECTION REPORT****Resident Engineer:**Pursell, Gary**Address:** 333 Burma Road**City:** Oakland, CA 94607**Report No:** WIR-002911**Date Inspected:** 11-Jun-2008**Project Name:** SAS Superstructure**OSM Arrival Time:** 630**Prime Contractor:** American Bridge/Fluor Enterprises, a JV**OSM Departure Time:** 1530**Contractor:** Zhenhua Port Machinery Company, Ltd (ZPMC), Changxing Island **Location:** Shanghai, China**CWI Name:** Hu Wei Qing and Lvliqing**CWI Present:** Yes No**Inspected CWI report:** Yes No N/A**Rod Oven in Use:** Yes No N/A**Electrode to specification:** Yes No N/A**Weld Procedures Followed:** Yes No N/A**Qualified Welders:** Yes No N/A**Verified Joint Fit-up:** Yes No N/A**Approved Drawings:** Yes No N/A**Approved WPS:** Yes No N/A**Delayed / Cancelled:** Yes No N/A**Bridge No:** 34-0006**Component:** OBG and SAS Tower Fabrication**Summary of Items Observed:**

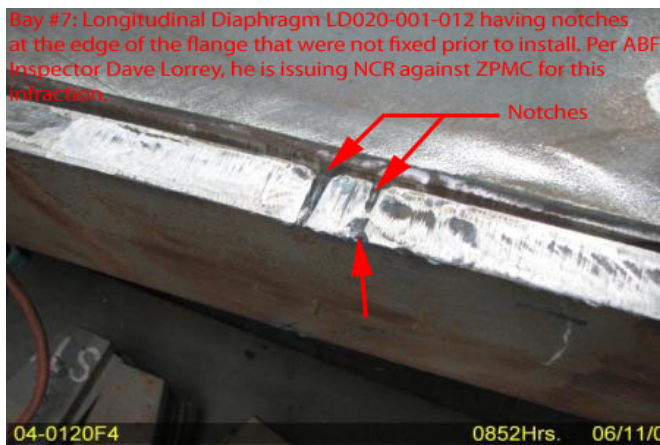
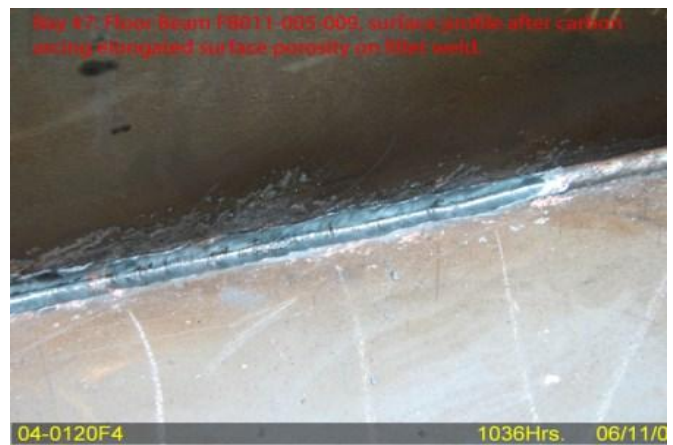
Flange to web plate fillet weld removal by carbon air arcing on floor beam sub-assembly FB011-005-009 and FB011-005-017 due to noted elongated and rounded surface porosity was observed. During the removal process, the carbon arc operator went 5.0mm too deep and 12.0mm wide into the web plate base metal. Since this is more than the Code ASTM A6 Paragraph 9.2.1 allowed, ABF Inspector informed ZPMC to make request to Caltrans for

base metal repair. See photo below.
